# Property Inspection Report

Property address: 3433 Jacona Dr

Jacksonville, Florida 32277

Inspection date: Wednesday, February 01, 2017

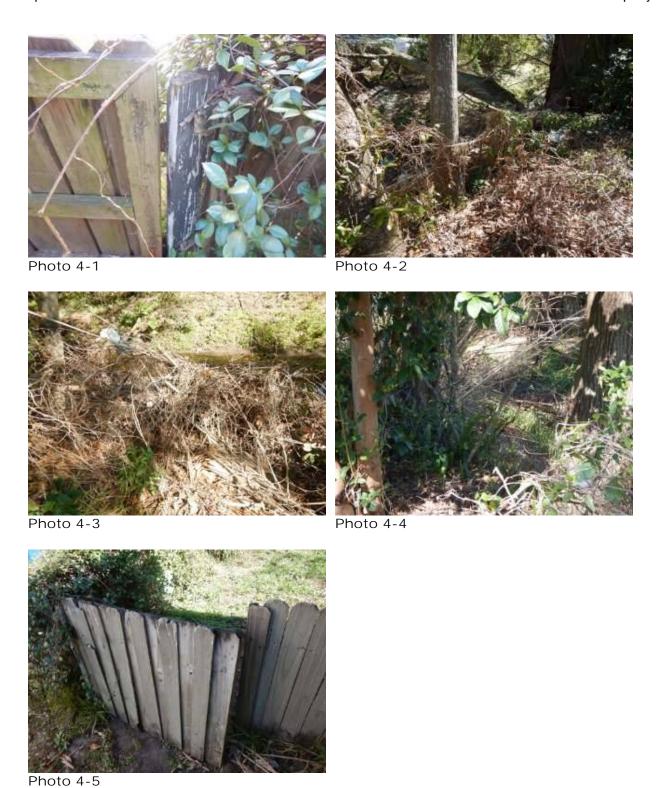
4) None or more fences and/or gates were damaged or deteriorated and need repair.

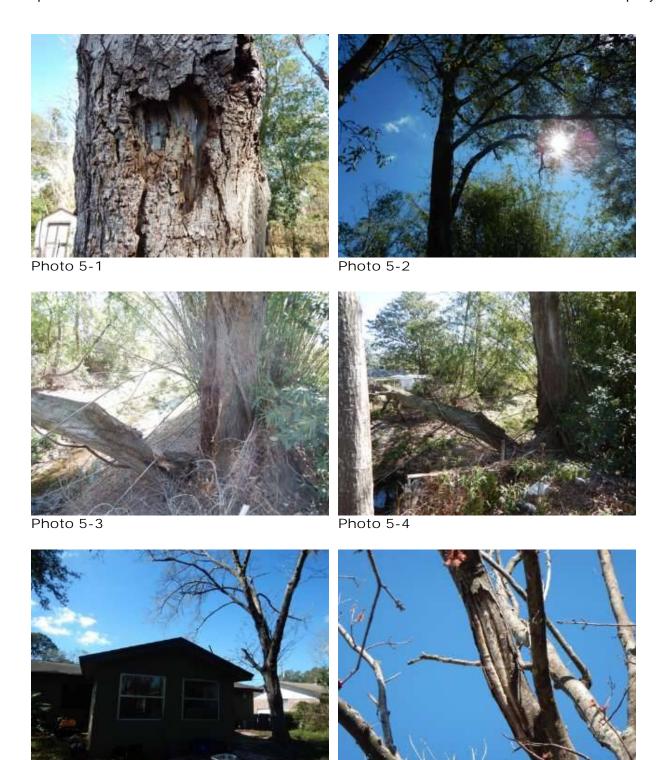
5) One or more significantly-sized diseased or dead trees were found on the property grounds and may pose of risk of damaging building(s). Recommend that such trees be removed by a qualified tree service contractor or certified arborist.

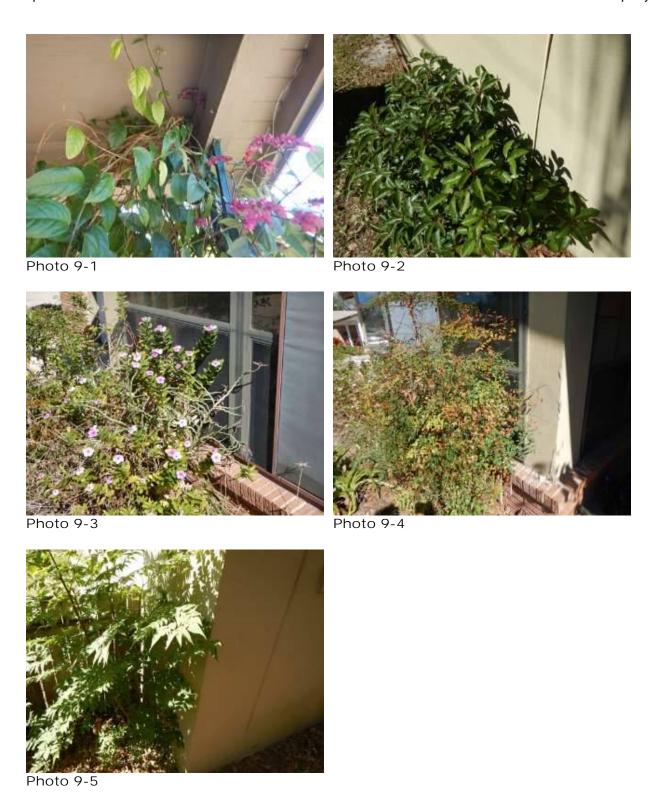
9) Vegetation such as trees, shrubs and/or vines was in contact with or close to the building exterior. Vegetation can serve as a pathway for wood-destroying insects and can retain moisture against the exterior after it rains. This is a conducive condition for wood-destroying organisms. Recommend pruning, moving or removing vegetation as necessary to maintain at least 6 inches of space between it and the building exterior. A 1-foot clearance is better.

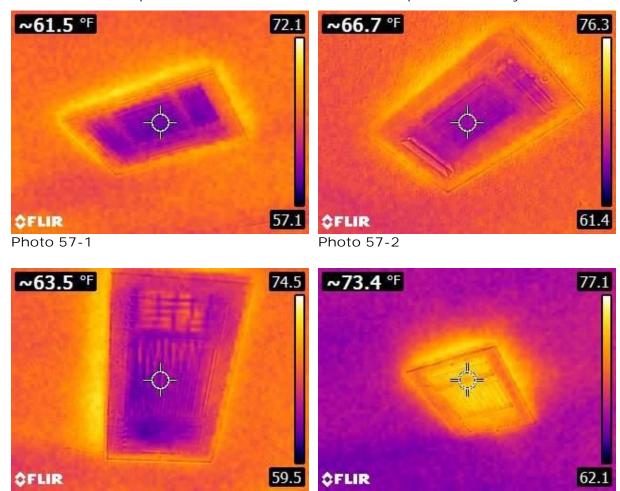
57) Supply air from the air conditioning or heat pump cooling system was not cool enough. It should be 14-20 degrees Fahrenheit cooler than at the return duct(s) or current room temperature. This may be caused by refrigerant loss, dirty coils, a failing compressor, an over-sized fan, or a deficient return-air system. Recommend that a qualified HVAC contractor evaluate and repair as necessary.

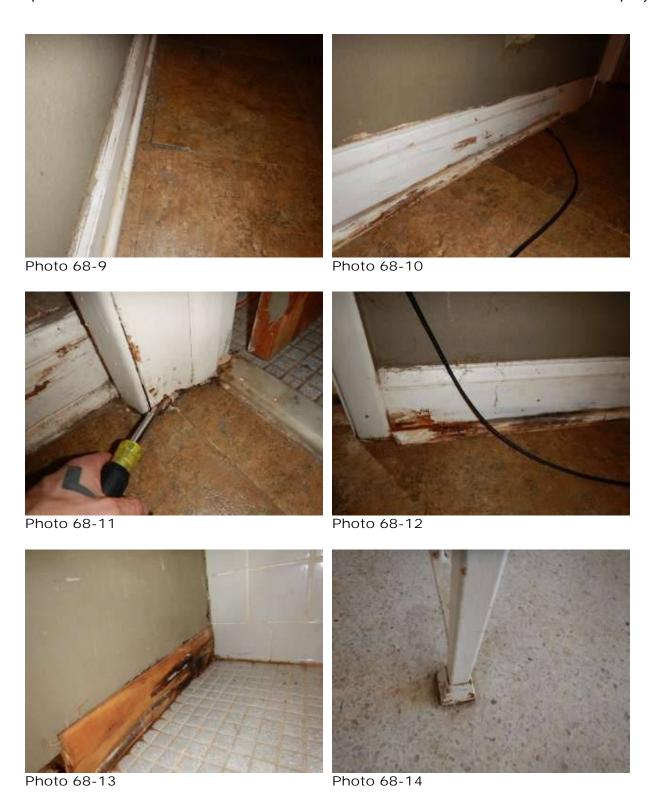
68) \ Damage and deterioration observed throughout interior. Recommend evaluation and repairs by a qualified contractor.

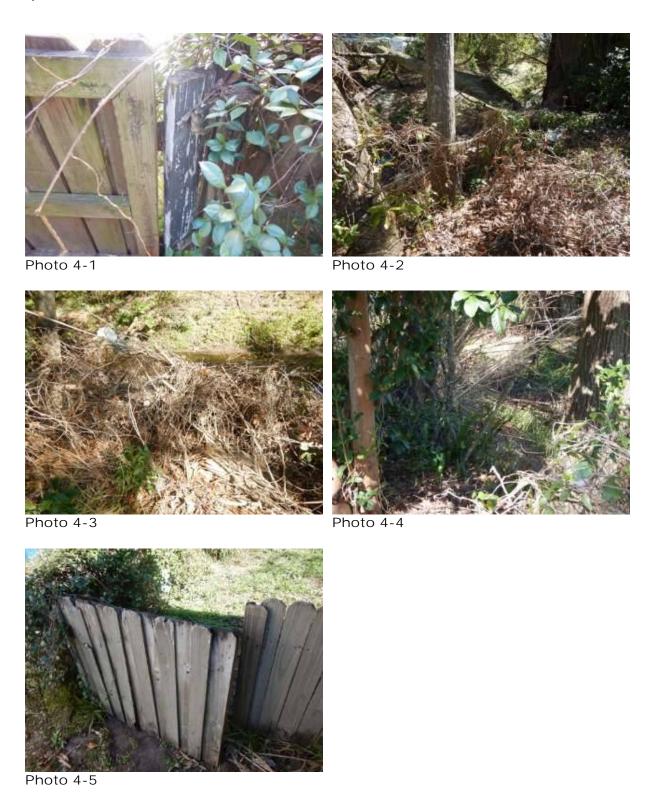
4 📏 - One or more fences and/or gates were damaged or deteriorated and need repair.

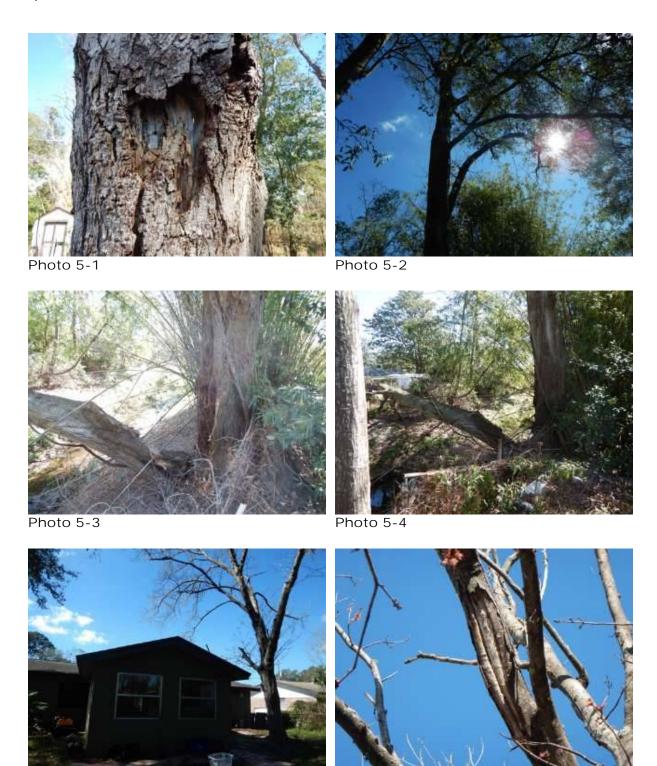
5 <a></a> - One or more significantly-sized diseased or dead trees were found on the property grounds and may pose of risk of damaging building(s). Recommend that such trees be removed by a qualified tree service contractor or certified arborist.

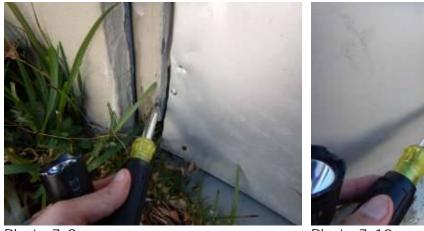
7) Fungal rot was found at one or more sections of siding or trim, soffits, gable ends and/or rafter tails. Conducive conditions for rot should be corrected (e.g. wood-soil contact, reverse perimeter slope). Recommend that a qualified person repair as necessary. All rotten wood should be replaced.

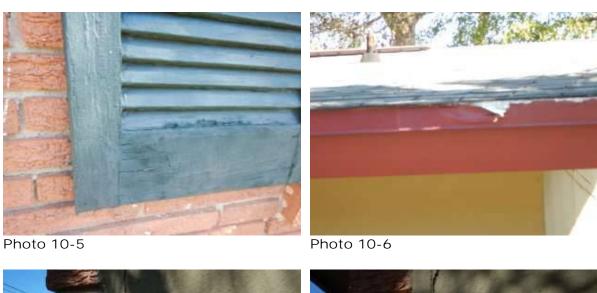
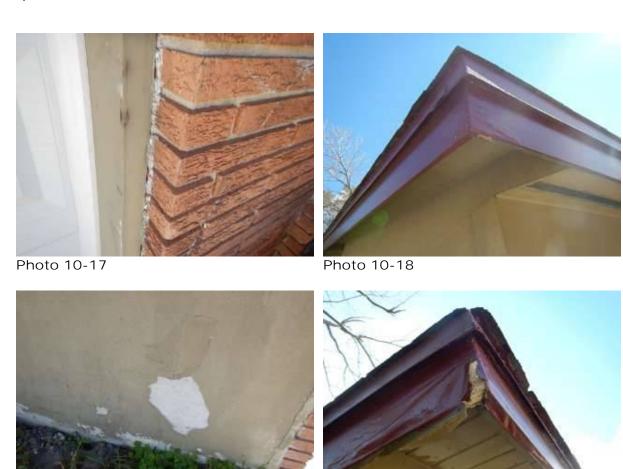
10) <a> Cracks and/or thin/failing paint observed. Recommend re-caulking and painting where needed by a qualified contractor.</a>

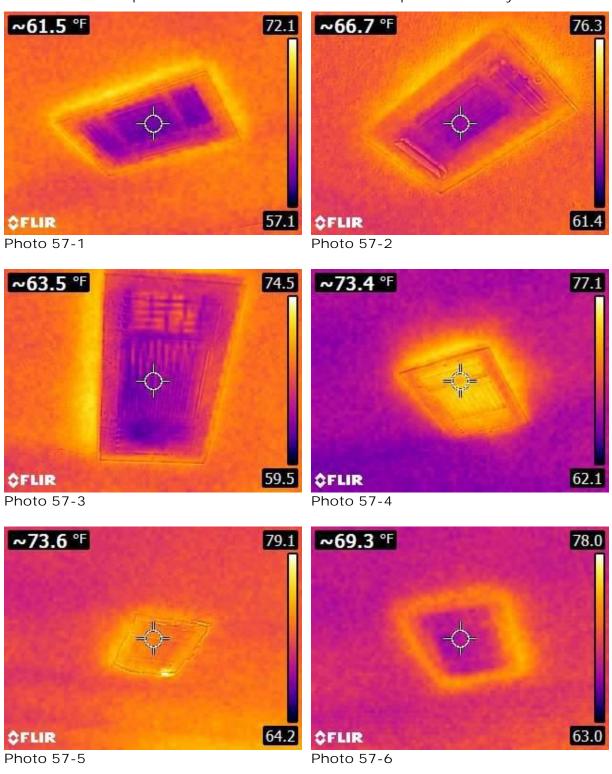
57 \ - Supply air from the air conditioning or heat pump cooling system was not cool enough. It should be 14-20 degrees Fahrenheit cooler than at the return duct(s) or current room temperature. This may be caused by refrigerant loss, dirty coils, a failing compressor, an over-sized fan, or a deficient return-air system. Recommend that a qualified HVAC contractor evaluate and repair as necessary.
