Property Inspection Report

Property address: 10341 West Jolynn Court

Jacksonville, Florida 32225

Inspection date: Tuesday, April 04, 2017

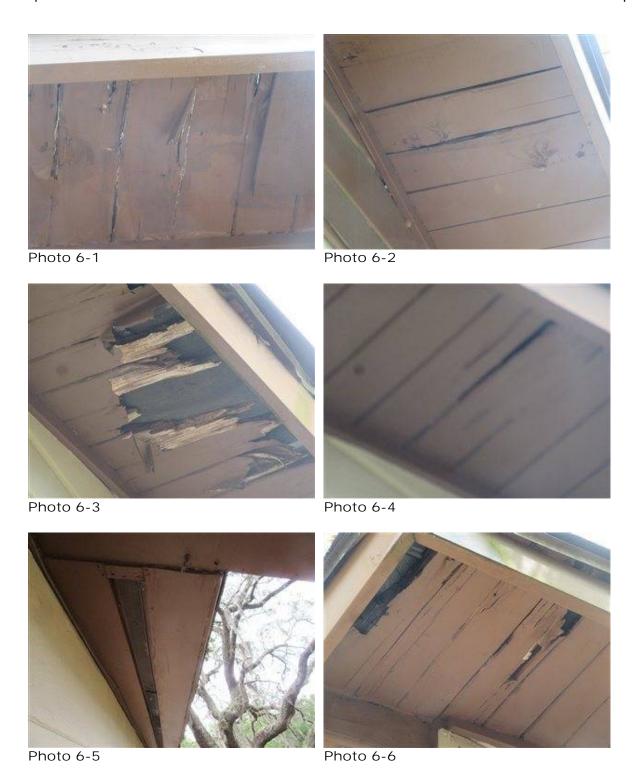
Photo 6-7

6) Rot was found in one or more areas on soffit boards. A qualified contractor should evaluate and make repairs as necessary, replacing all rotten wood.

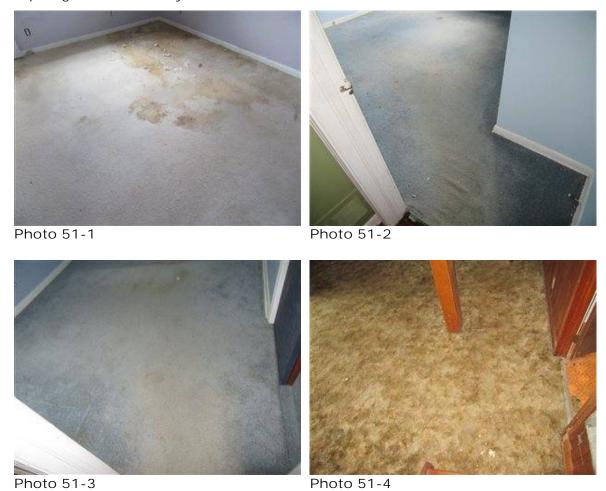
51) Carpeting in one or more rooms is damaged and/or significantly deteriorated. Recommend replacing carpeting where necessary.

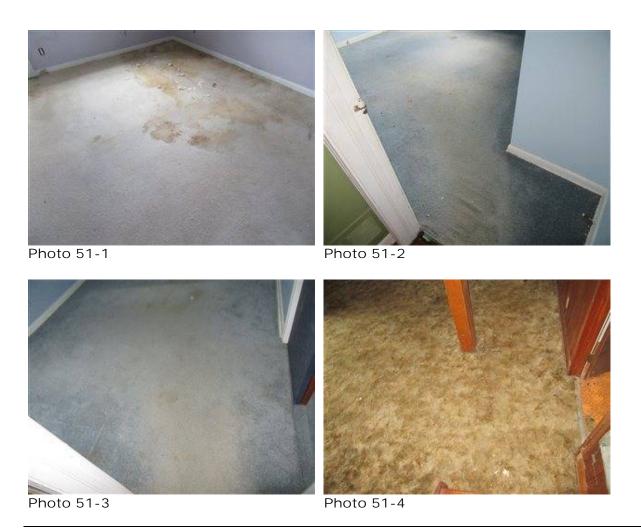
51 51 - Carpeting in one or more rooms is damaged and/or significantly deteriorated. Recommend replacing carpeting where necessary.
